**PROPOSED ELECTRICAL LINE OF 2 X 400 kV WHICH RUNS FROM
ARIES SUBSTATION NEAR KENHARDT TO UPINGTON
SUBSTATION NEAR UPINGTON, IN THE KAI GARIB AND KHARA
HAIS LOCAL MUNICIPALITY, MGCAWU DISTRICT MUNICIPALITY,
NORTHERN CAPE PROVINCE**

HERITAGE CONSERVATION MANAGEMENT PLAN

Date: 30August 2024

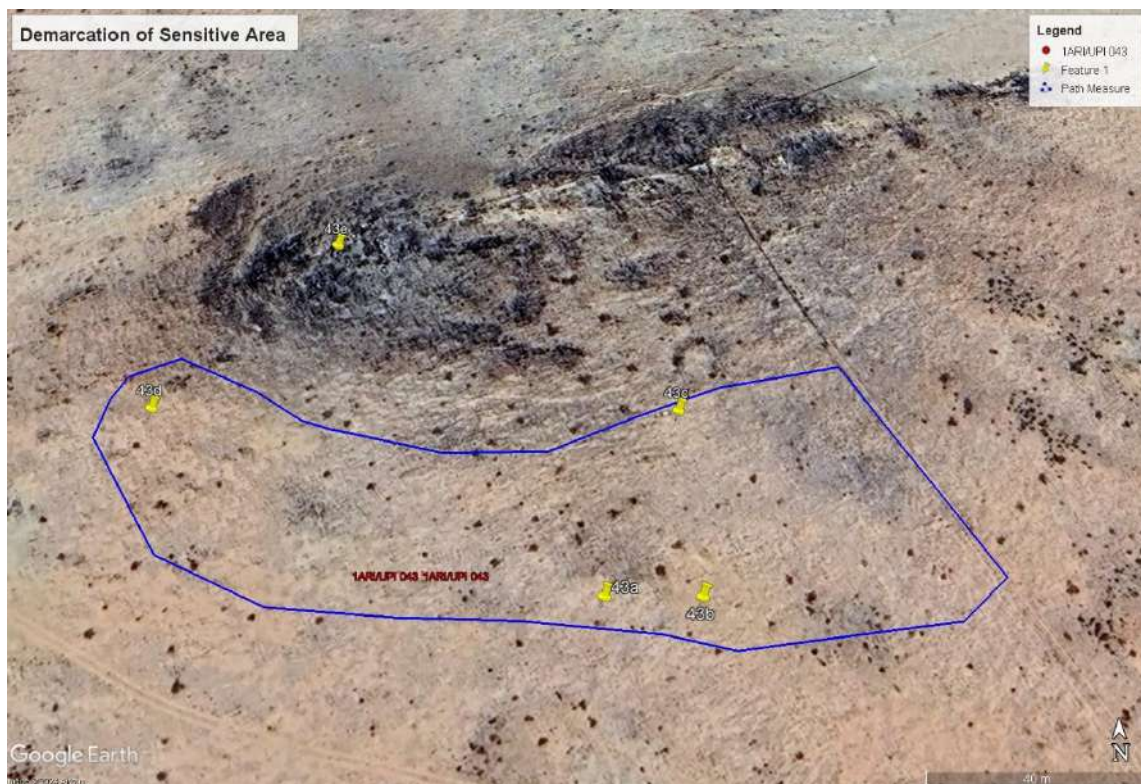
Figure 1: Tower 43, demarcation of sensitive area to be monitored, areas outside the tower footprint to be preserved.

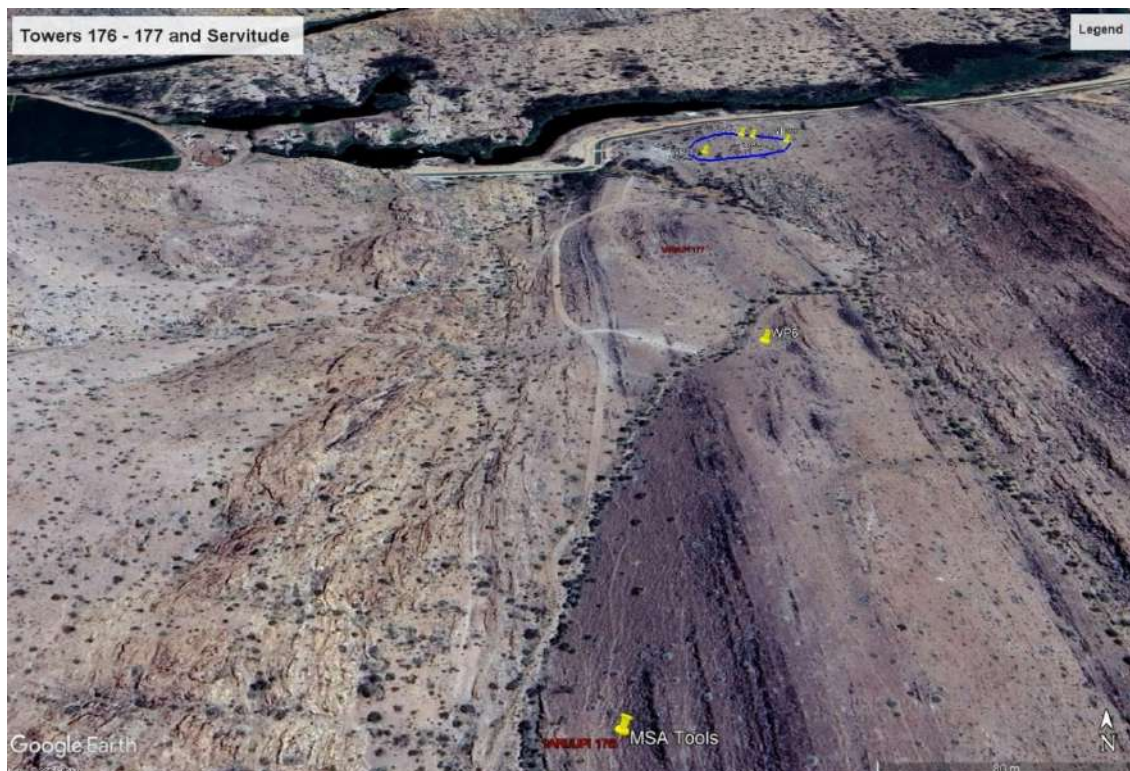
Figure 2: Towers 176 – 177, few finds at Tower 176; nothing found at Tower 177. MSA/LSA at Waypoint (WP6) to be preserved.

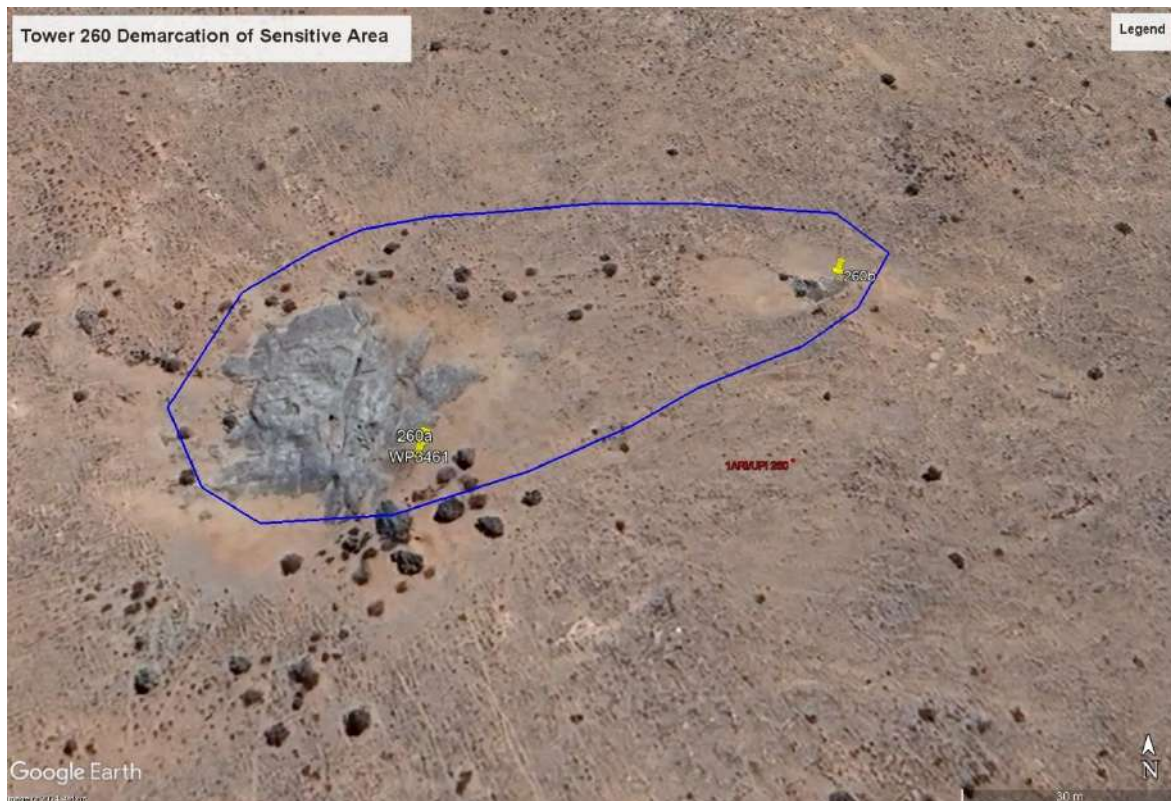
Figure 5: Tower 260, demarcation of sensitive area to be monitored, areas outside the tower footprint to be preserved.

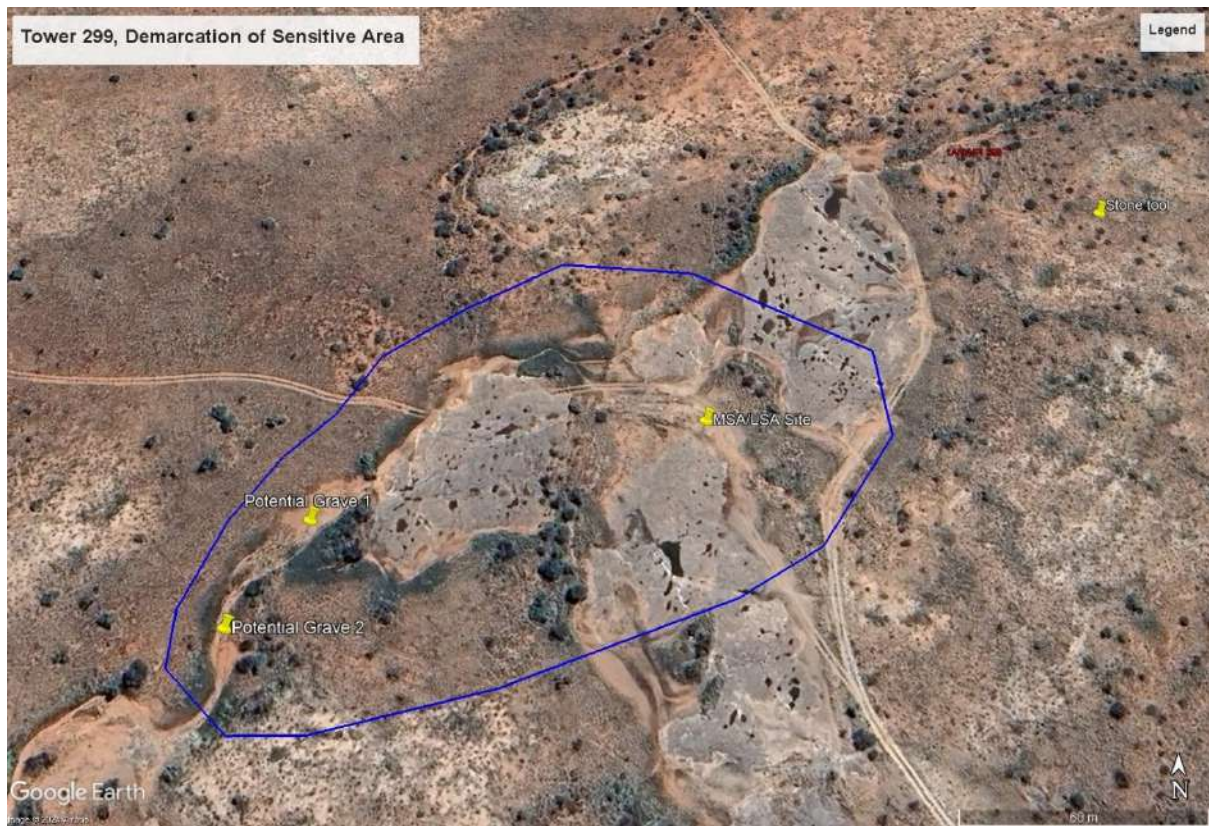
Figure 7: Tower 299, demarcation of sensitive area to be monitored, screening excavation of potential graves recommended.

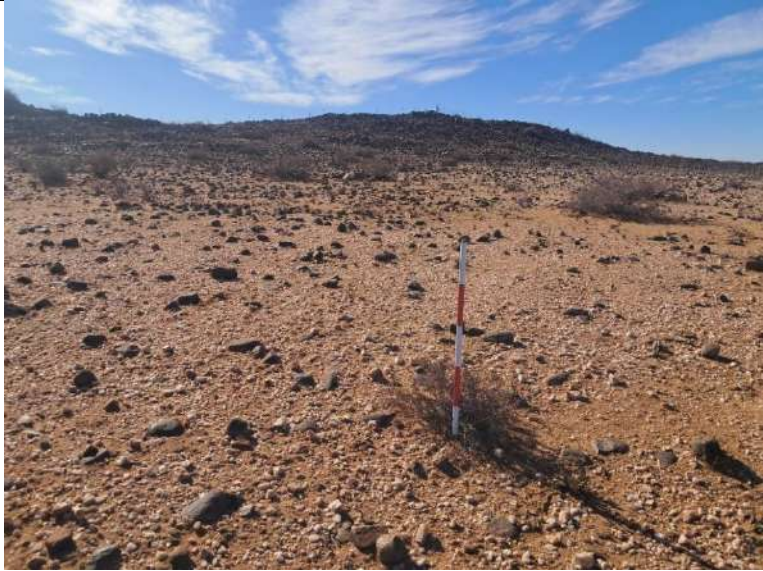
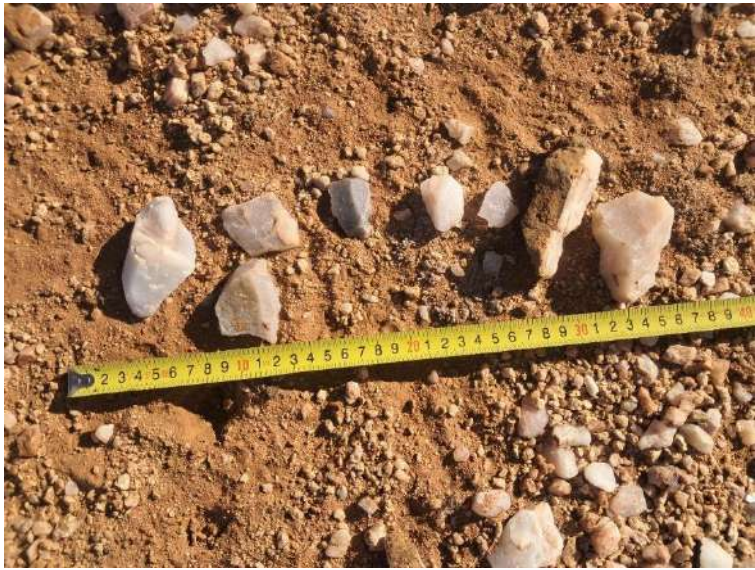
Tower No	Coordinates		Finds in or Close to the Servitude
T43	29°19'59.50"S	20°46'28.30"E	Extensive scatter of MSA/LSA tools/flakes

DESCRIPTION: Extensive scatter of MSA/LSA tools mostly quartz found on the southern foot of the hill. A modern chamber of cement built on top of the hill.

MITIGATION	Avoid southeastern part of the hill. Monitoring foundation excavations.
DATE	17 th July 2024

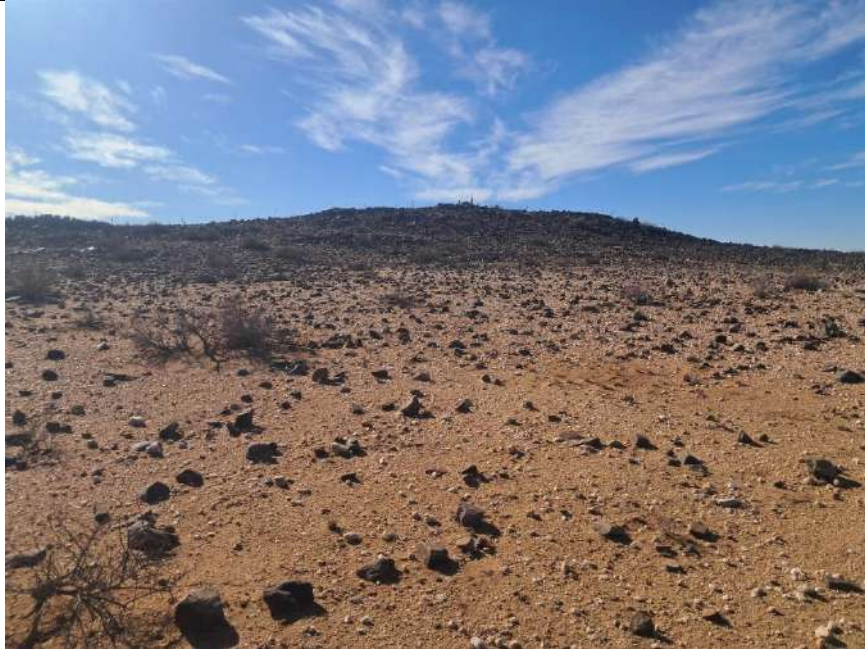
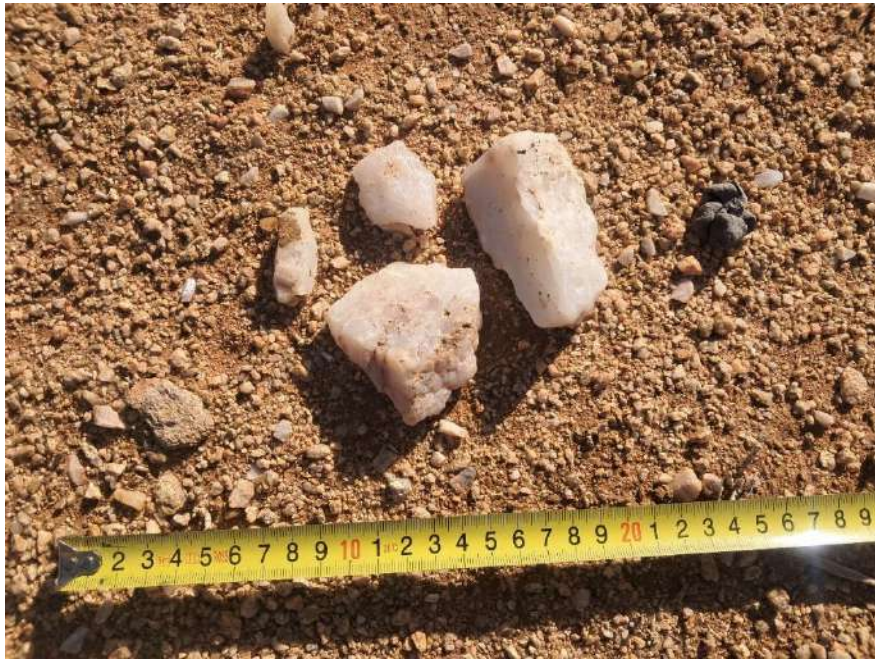
DATE		17 th July 2024	
Tower No	Coordinates		Finds in or Close to the Servitude
T43b	29°19'58.20"S	20°46'28.90"E	Extensive scatter of MSA/LSA tools

DESCRIPTION: DESCRIPTION: Extensive scatter of MSA/LSA tools mostly quartz found on the southern foot of the hill. A modern chamber of cement built on top of the hill.			
MITIGATION	Avoid the southeastern part of the hill. Monitoring foundation excavations.		
DATE	16 th July 2024

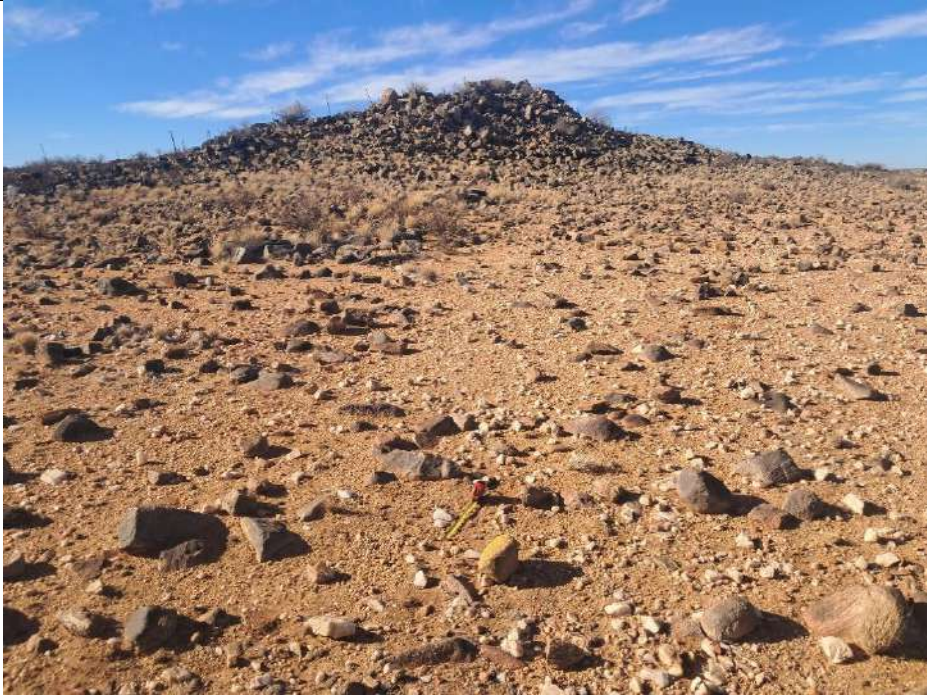
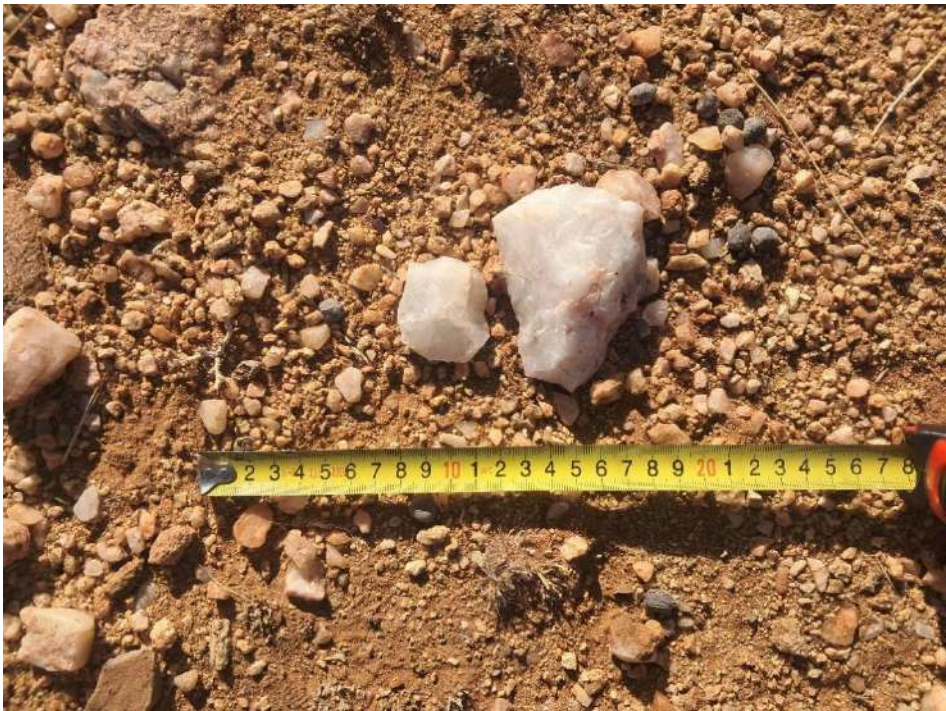
Tower No	Coordinates		Finds in or Close to the Servitude
T43c	29°19'58.50"S	20°46'28.30"E	Extensive scatter of MSA/LSA tools

DESCRIPTION: DESCRIPTION: Extensive scatter of MSA/LSA tools mostly quartz found on the southern foot of the hill. A modern chamber of cement built on top of the hill.			
MITIGATION	Avoid the southeastern part of the hill. Monitoring foundation excavations.		
DATE	16 th July 2024		
Tower No	Coordinates		Finds in or Close to the Servitude

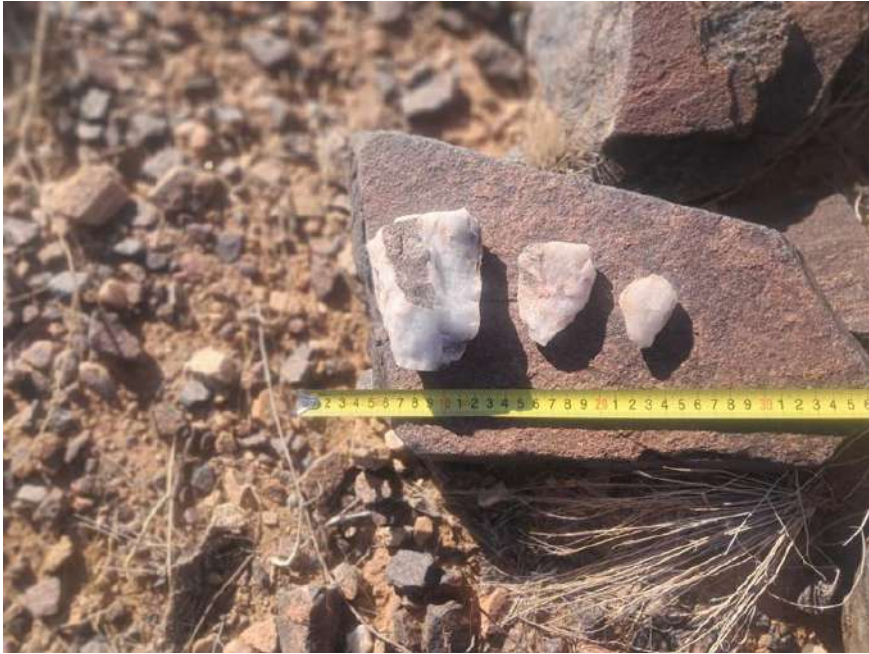
Tower No	Coordinates		Finds in or Close to the Servitude
T176	24°47'26.30"S	20°42'14.20"E	A small cleaver, scraper and flake found.

DESCRIPTION: A small cleaver, scraper and flake found.			
MITIGATION	Construction to proceed with monitoring.		
DATE	16 th July 2024

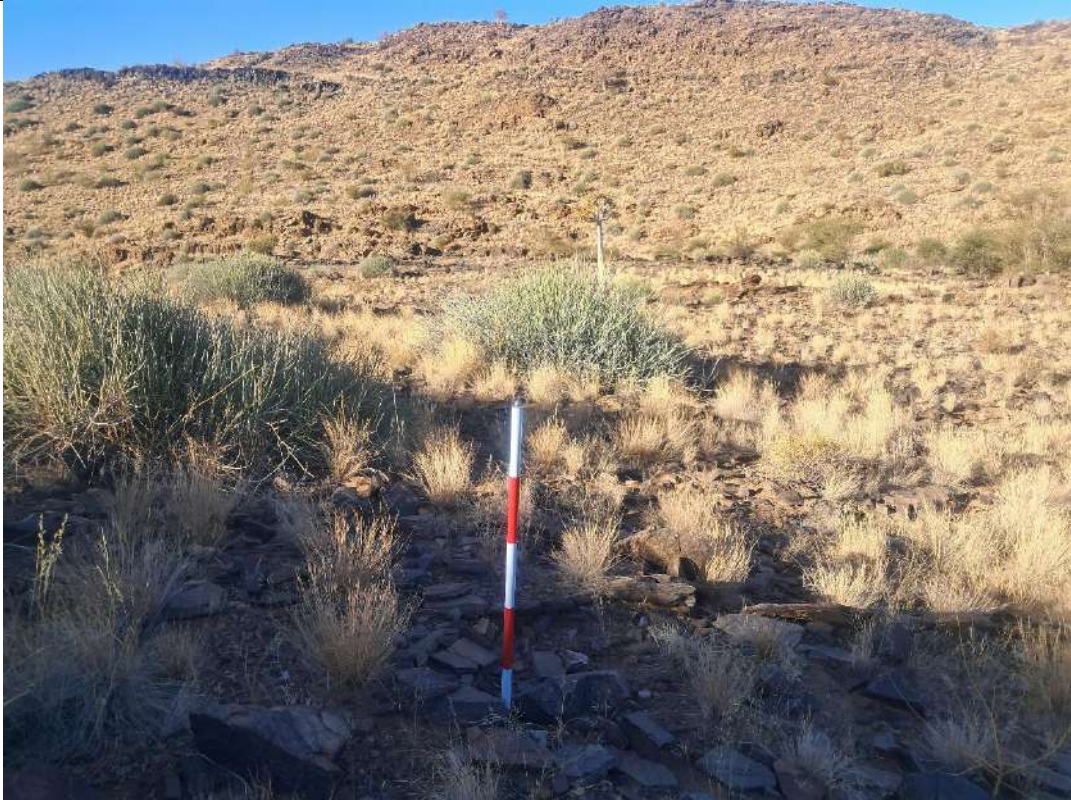
Tower No	Coordinates		Finds in or Close to the Servitude
T177			Nothing found

DESCRIPTION: Quartz waste found, no tools.			
MITIGATION	Construction to proceed without monitoring.		
DATE	16 th July 2024

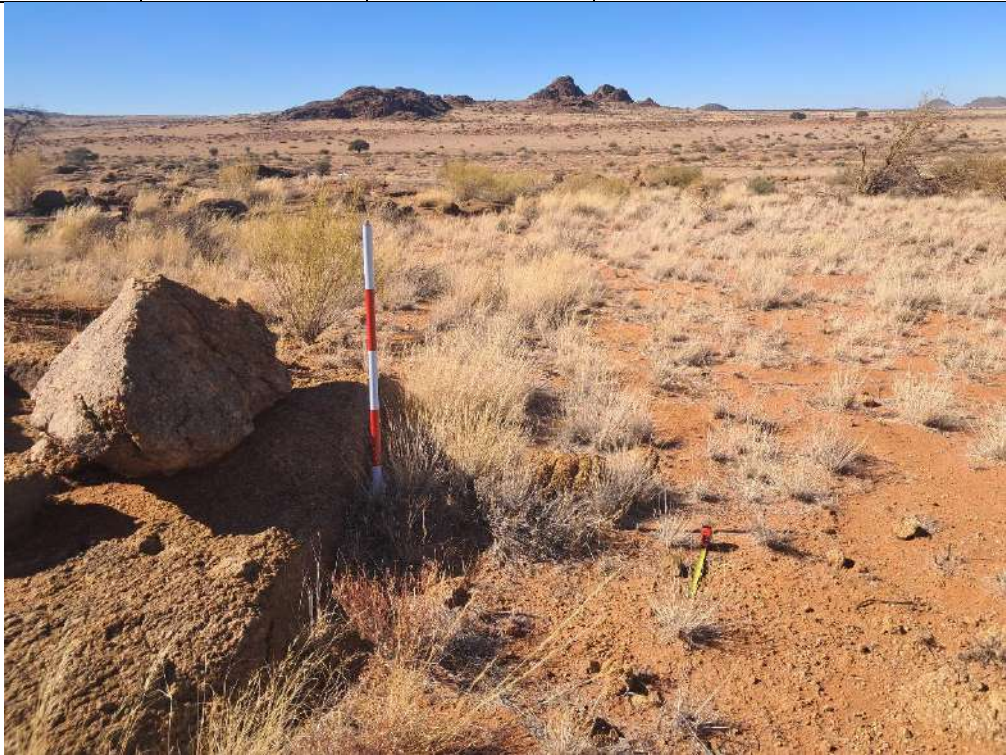
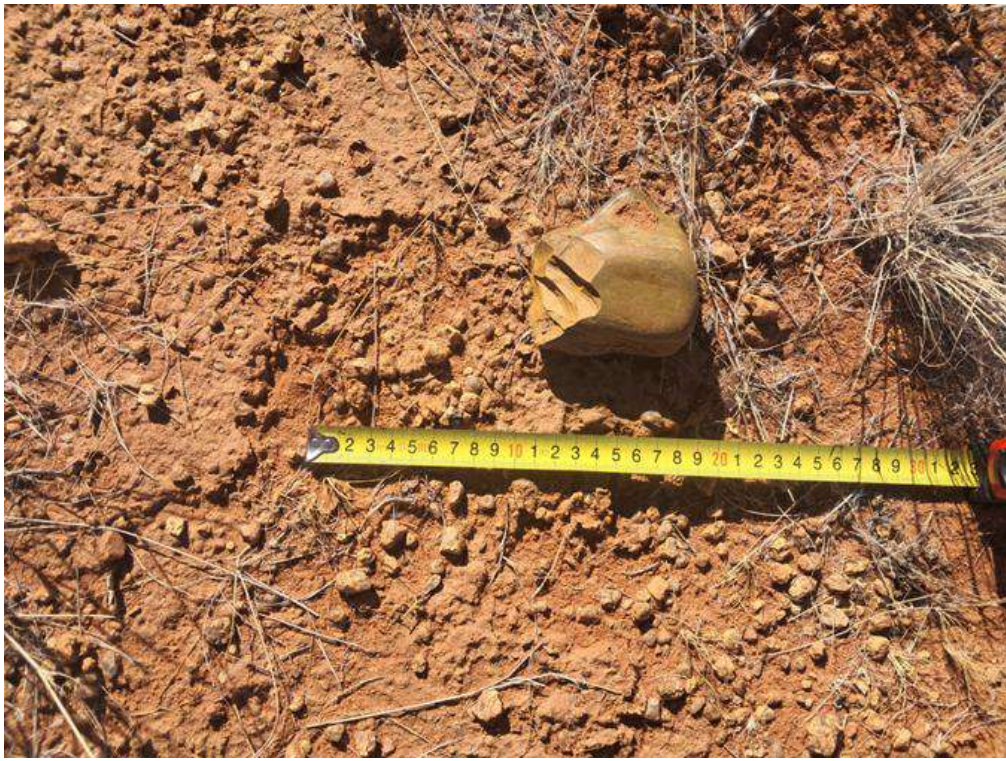
Tower No	Coordinates		Finds in or Close to the Servitude
T219b	28°41'5.90"S	20°43'9.20"E	A core

DESCRIPTION: A core found in the outcrop area.			
MITIGATION	Area around the outcrop to be demarcated and avoided.		
DATE	16 th July 2024

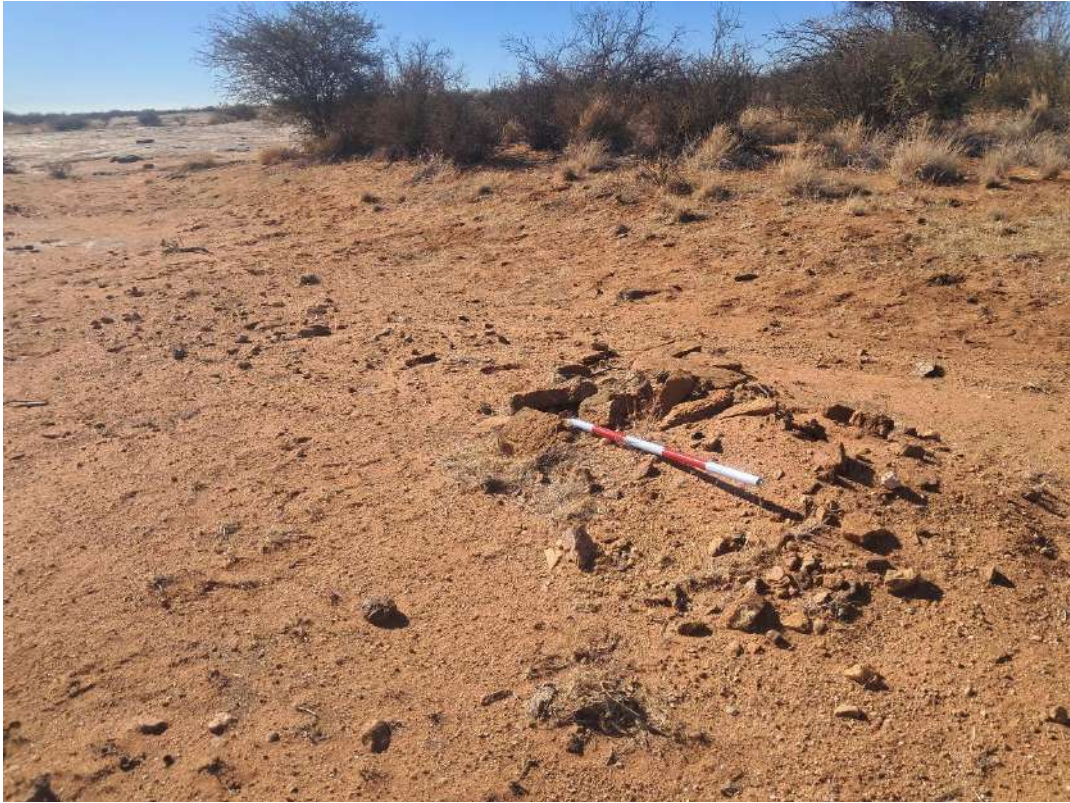
Tower No	Coordinates		Finds in or Close to the Servitude
T299e	28°35'24.41"S	21° 5'19.74"E	Potential Grave 2

DESCRIPTION. Potential grave on the edge of the outcrop.			
MITIGATION	Screening excavations of the potential graves recommended.		
DATE	18 th July 2024
